**DHE-TSANG MONASTERY:
PROTECTOR TEMPLE ARCHITECTURAL REPORT
AUGUST '02**

**KHAM AID FOUNDATION
ART AND ARCHITECTURAL CONSERVATION PROGRAM**

PROTECTOR TEMPLE: CONDITIONS ASSESSMENT

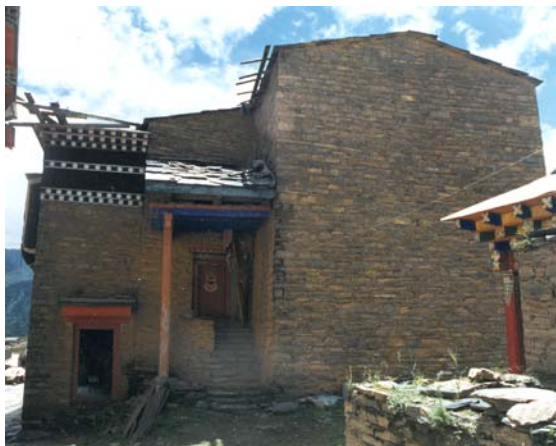
Exterior north wall of Protector Temple, with clear separation between earlier structure and new portico.

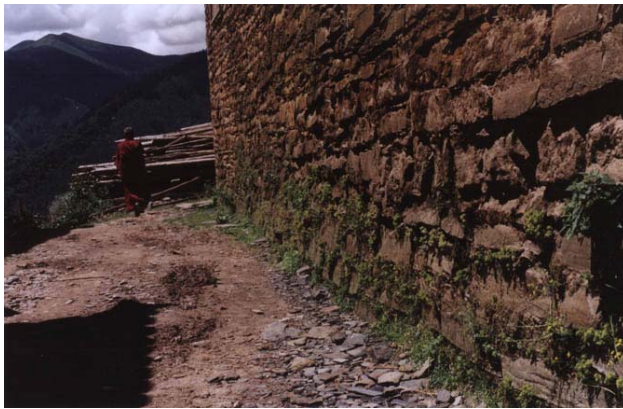
South exterior wall of the Protector Temple with extensive plant growth at the base, evidence of excess moisture in the building fabric. The roof of the nearby kitchen (note shadow) and the roof of the Protector Temple shed large amounts of water into this narrow alley during downpours. Lack of adequate drainage results in moisture creeping up the walls of the building through capillary rise.

not catch and lead away the water from the north of the building, where water from the north runs into the base of the structure. Adequate drainage is also required at the south wall, where there is insufficient clearance between the temple and the neighbouring kitchen. In addition, the kitchen roof overhang directs water to the south wall of the temple, and has led to widespread mortar loss and substantial biological growth, i.e. mosses, lichens, and other vegetation.

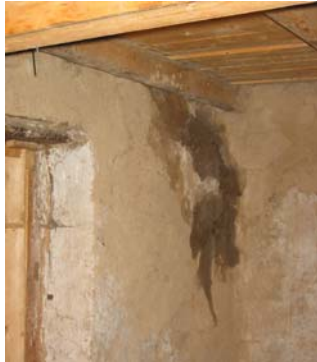
Moisture infiltration at the SE corner of the upper floor of the new portico

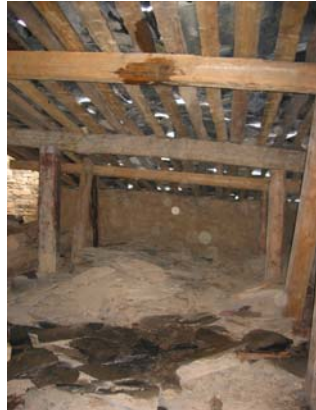
Inadequate coverage of slate results in water infiltration soaking the roof frame and the fabric beneath it. This leak showed repercussion through the building down to the ground floor.
