**CONSERVATION OF THE PROTECTOR TEMPLE, DHE-TSANG MONASTERY,
Ma'erkang County, Aba Prefecture, Sichuan Province, CHINA**

First Campaign Trip Report
August 2002

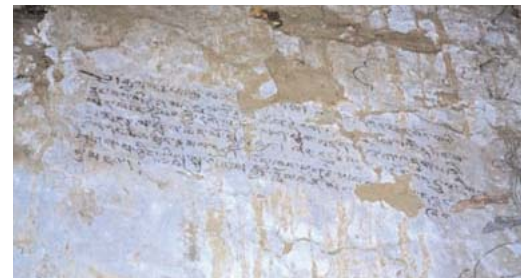
6th Dalai Lama's inscription

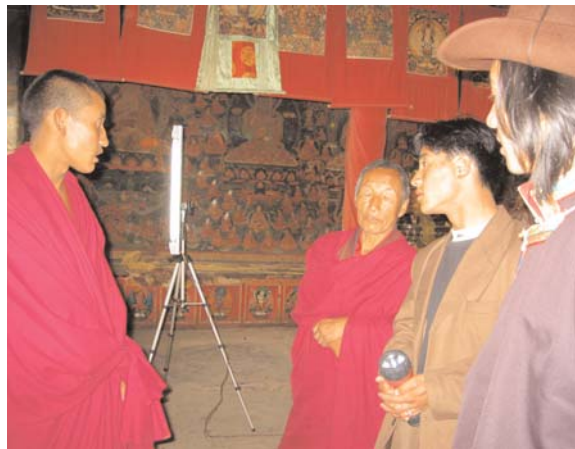
Protector Temple / Main Hall

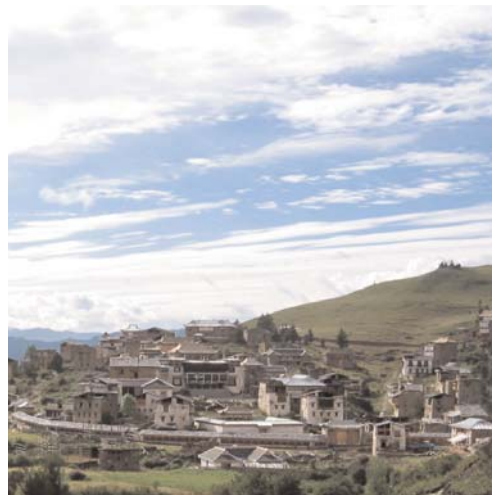
established by the founder and, thus, was given its name, meaning "completion". Further investigation is required to determine if Dhe-Tsang's founder did indeed establish any other monasteries during his lifetime.

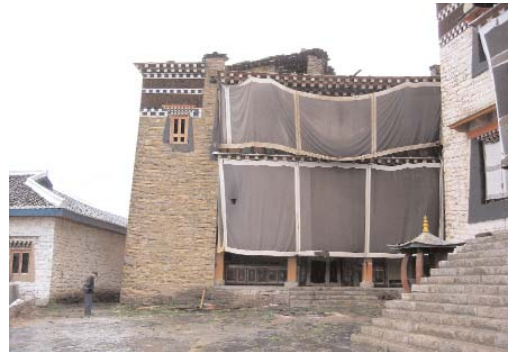
Very little is known about the history of the Protector temple. In its recent history the Protector Temple was used as a storage warehouse during the Cultural Revolution. It reopened circa 1983 and has been used as a place of worship up to the present day.

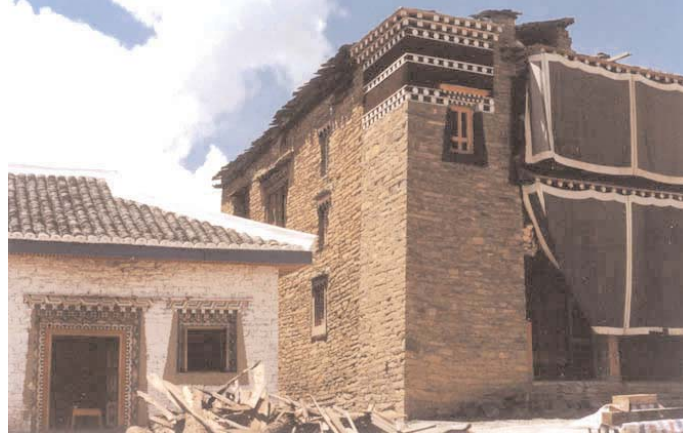
Protector Temple / Main Hall

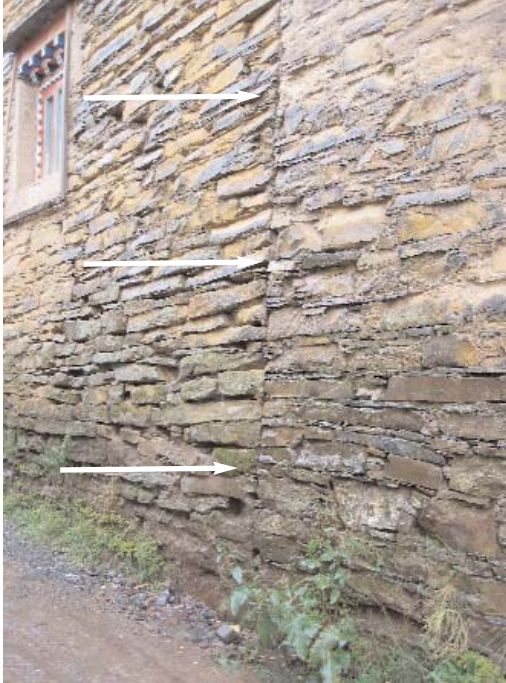
The condition of the east wall is obscured by the addition of the new porch. A clear division exists on the exterior south wall that delineates the main hall from the new porch addition suggesting that a pre-existing structure would have also been built up against the Protector Temple as a separate unit.

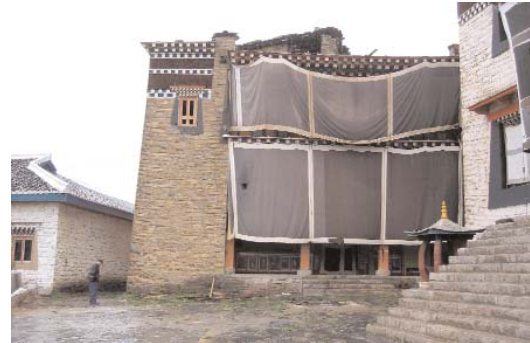
Protector Temple / Exterior East Wall

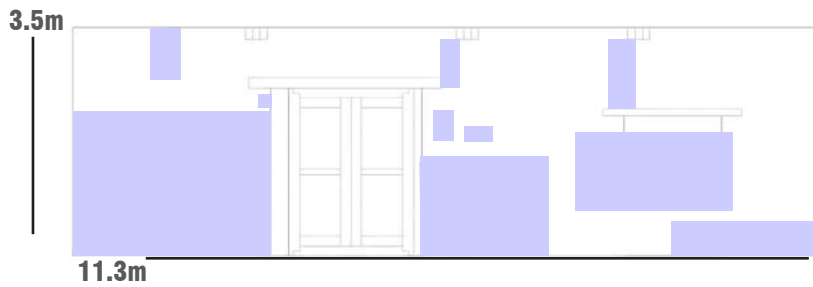
Graphic condition recording of the interior east wall showing general patterns of deterioration

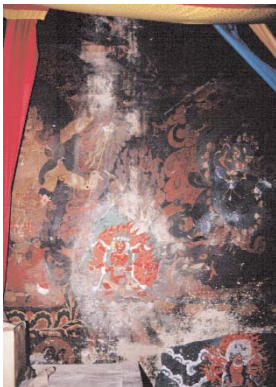
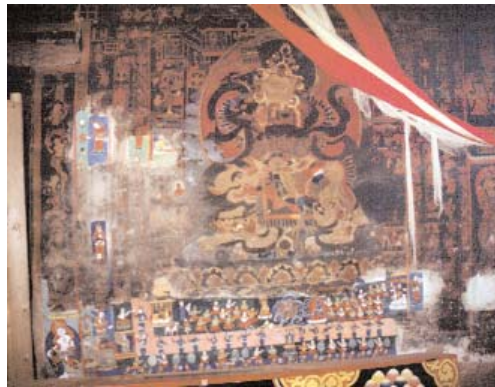
Protector Temple / Interior East Wall

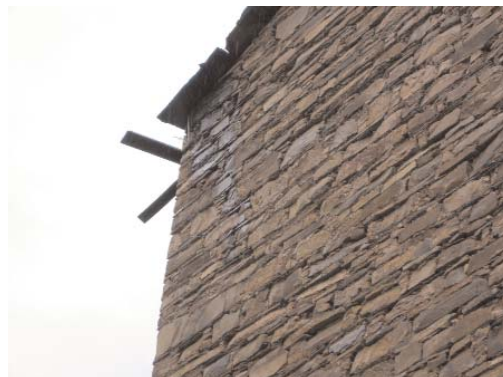
Protector Temple / Exterior South Wall

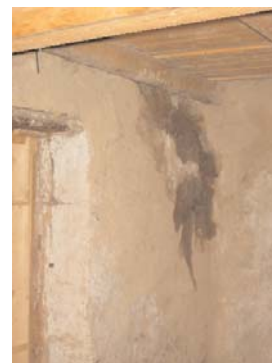
Protector Temple / Interior South Wall

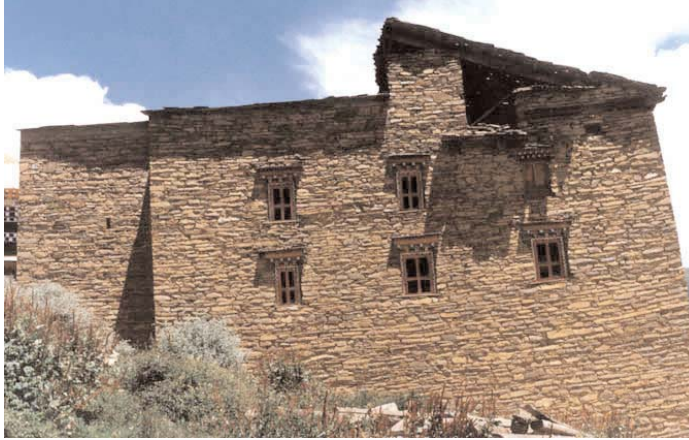
Protector Temple / Exterior West Wall
General view
August, 2002

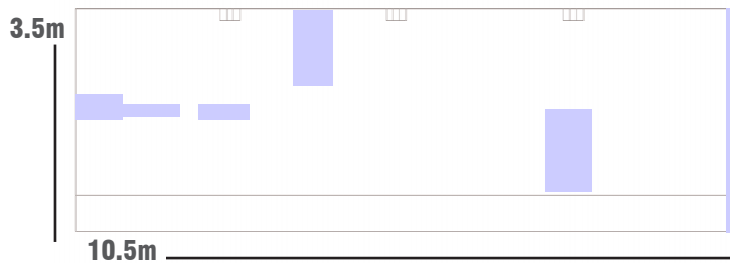
Protector Temple / Main Hall

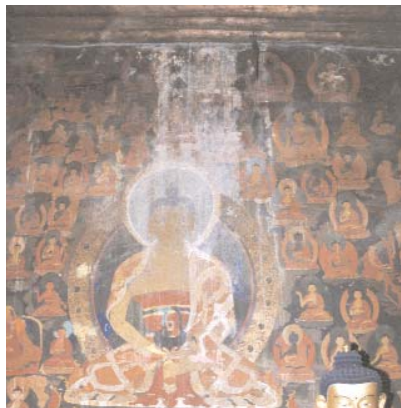
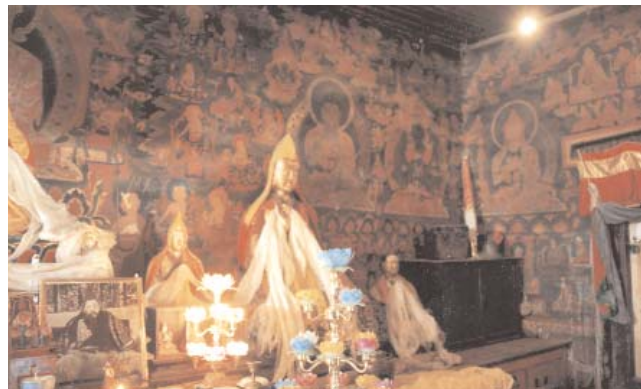
Protector Temple / Interior West Wall

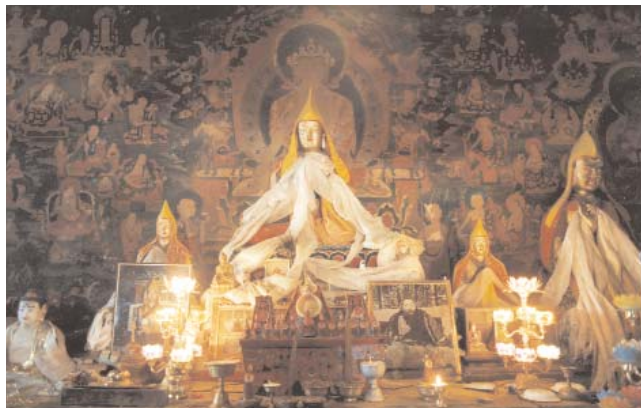
Protector Temple / Interior West Wall

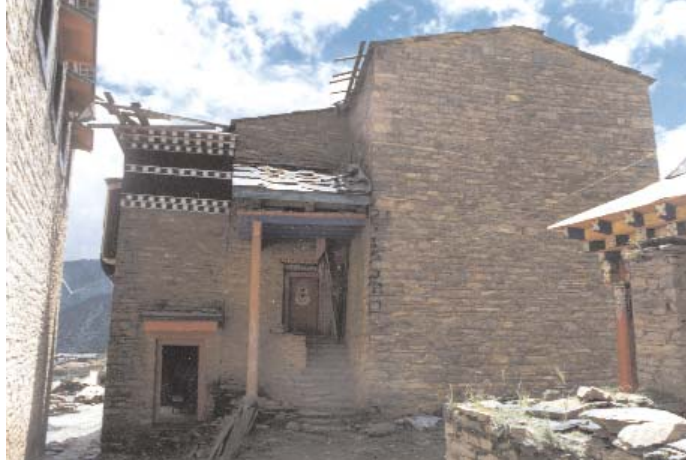
Protector Temple / Exterior North Wall

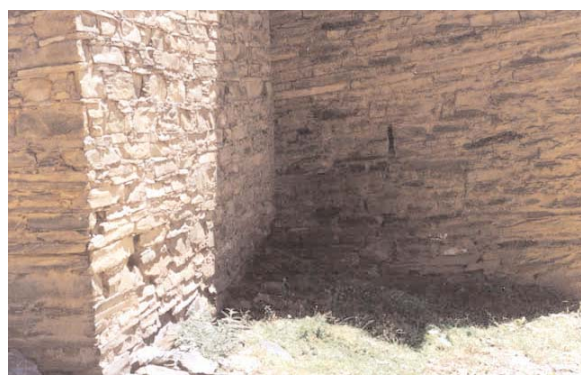
Protector Temple / Exterior North Wall

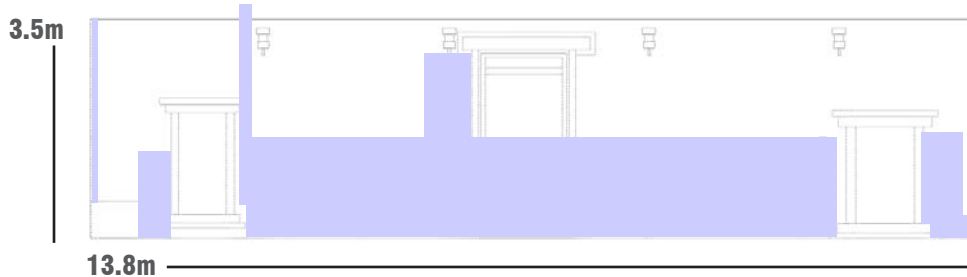
Protector Temple / Main Hall

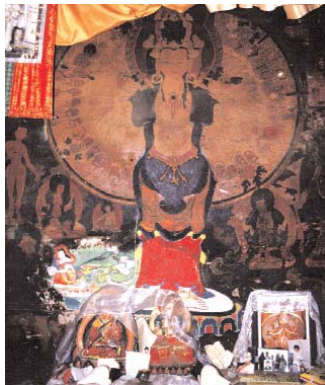
area. There are also losses through to the stone support of the dado repair plaster running along the base of the wall. The area of painting to the east of the northeast side room is particularly heavily abraded. Interestingly, it appears that there are two schemes of paintings present here (as seen on the north side of the east wall) though time did not permit further investigation. Several large cracks run from ceiling to floor and are thought to be associated with movement of the wooden ceiling beams (see Architectural Team Report).

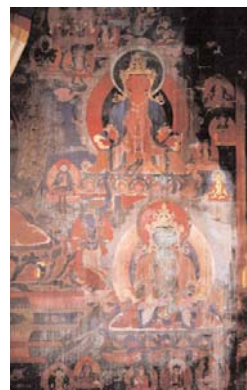
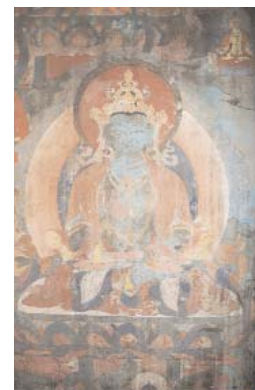
Protector Temple / Main Hall / North Wall

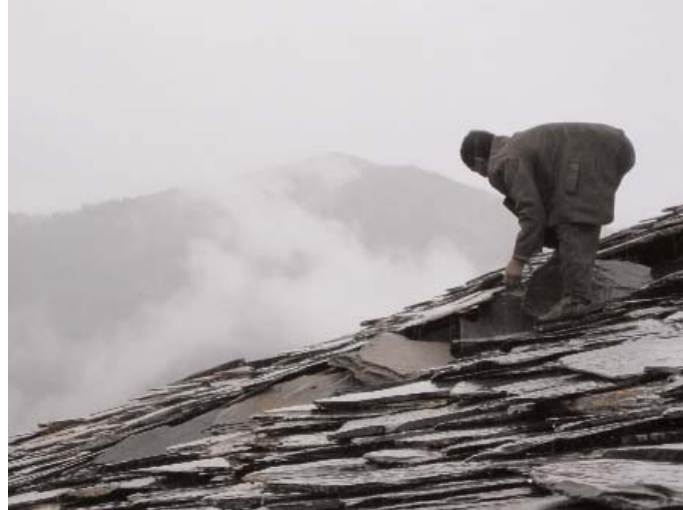
Protector Temple / Roof

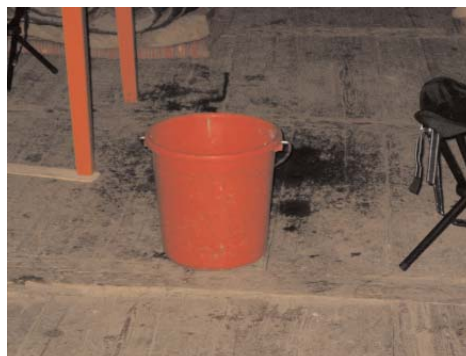
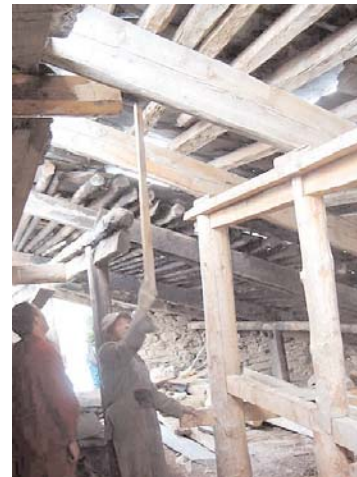
Protector Temple / Roof

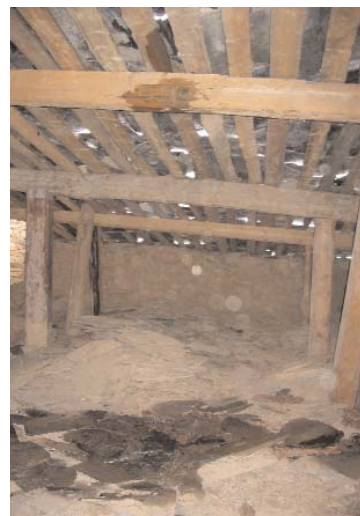
Protector Temple / Roof

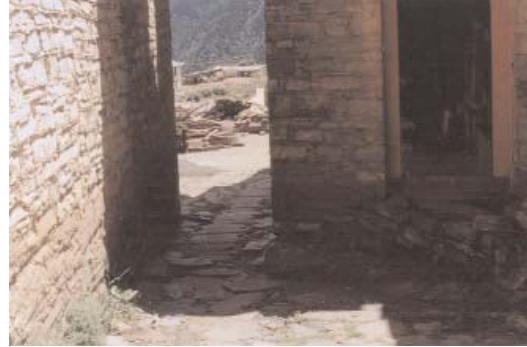
Protector Temple / Exterior

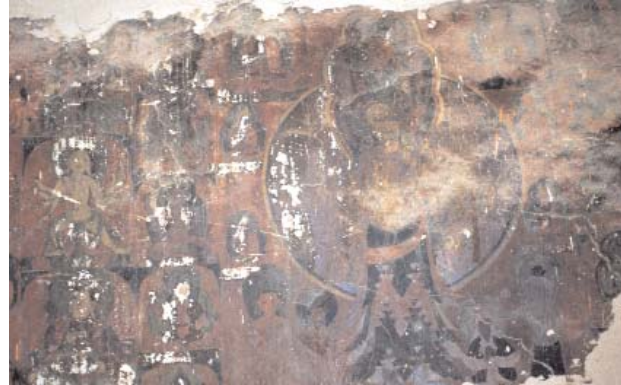
Protector Temple / Mahakala Temple
View of paintings on the south wall
August, 2002

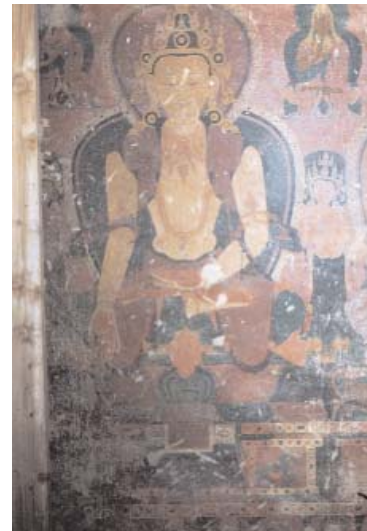
Protector Temple / Mahakala Temple
Detail of paintings
August, 2002
