**DHE-TSANG MONASTERY:
PROTECTOR TEMPLE ARCHITECTURAL REPORT
AUGUST '02**

**KHAM AID FOUNDATION
ART AND ARCHITECTURAL CONSERVATION PROGRAM**

PROTECTOR TEMPLE: CONDITIONS ASSESSMENT

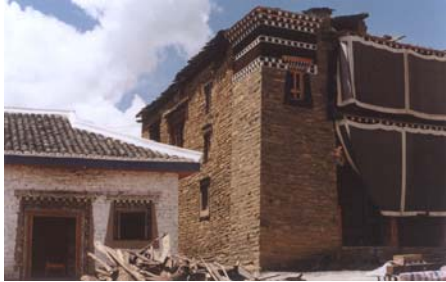
*Southeast corner of Protector Temple,
flanked by new kitchen building to south*

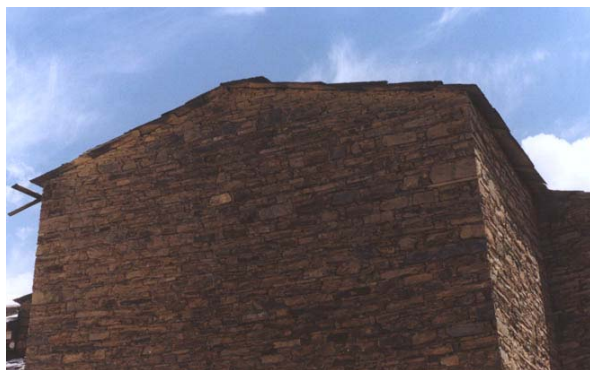
Exterior north wall of Mahakala room, with larger addition in the background

Viewed from the exterior north wall, the Mahakala room protrudes out by over 4 meters from the wall plane of the addition. At the inside corners, it is apparent that the later masonry construction is not stitched into the previously existing stone coursing. Another difference is the bond pattern; the older walls have alternating courses of larger stones with smaller stones. The adjoining walls feature similarly sized courses, with stacks of small stones in between the larger units. In addition, the Mahakala room walls have reinforcing timber members, which are noticeably absent from the later construction.
